**Mercury Lamp
Drum-Top Crusher
Study**

TABLE OF CONTENTS

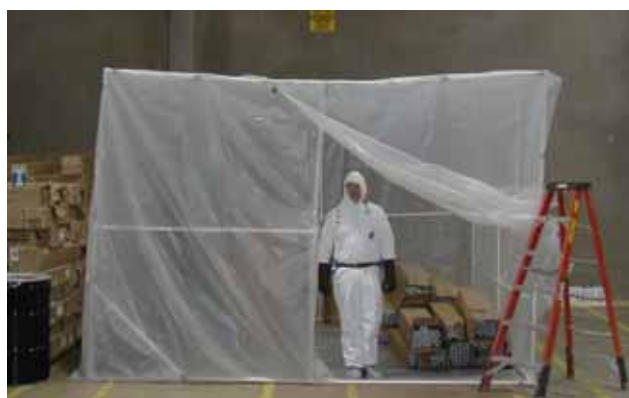
Photograph 2.2: EPSI Phoenix Facility - Containment Structure

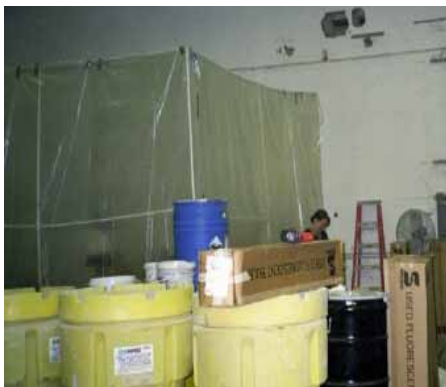
Photograph 2.3: AERC Melbourne Facility - Containment Structure

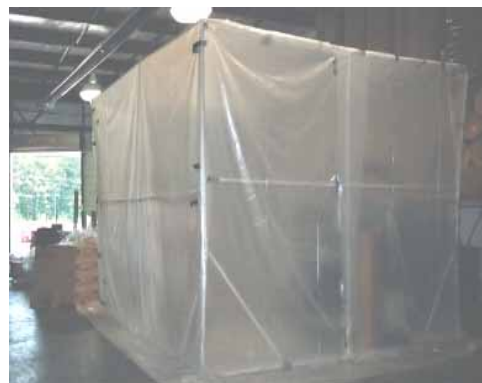
Photograph 2.4: AERC Ashland Facility - Containment Structure - Second Visit

The polyethylene walls, floor, and ceiling were changed before testing each device at each location. The containment structure used a “flap” door to allow entry and exit by the operators. This door, which overlapped the walls, limited the amount of air exchanged between inside and outside the containment structure; however, it was not possible to entirely eliminate air exchanges.

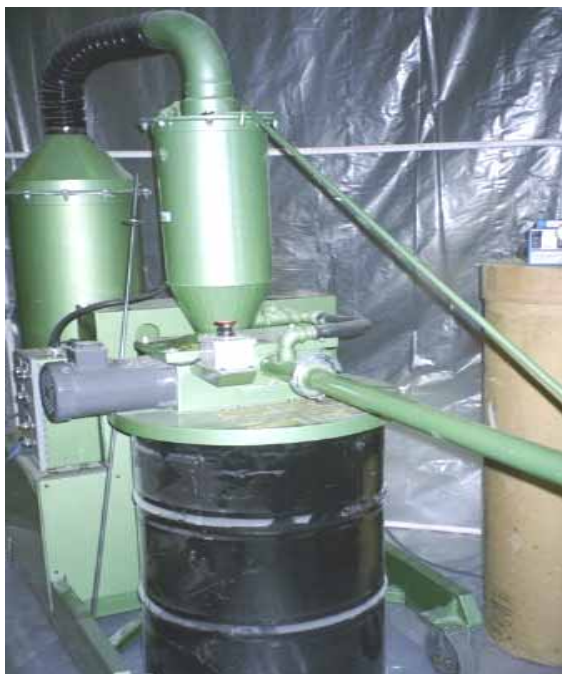
Photograph 2. 5: Manufacturer A Device

- Manufacturer A (*Photograph 2. 5*)
- Manufacturer B (*Photograph 2. 6*)
- Manufacturer C (*Photograph 2. 7*)
- Manufacturer D (*Photograph 2. 8*)

All manufacturers except Manufacturer A provided new, unused DTC devices for the Study. Manufacturer A provided a prototype machine that was used prior to the Study, but was cleaned and decontaminated by the manufacturer before it was sent for testing in the Study. For reasons that are discussed in Section 3.5.1 of this report, the Manufacturer D device was tested only during Phase I of the PVS and the first round of the EFTS.

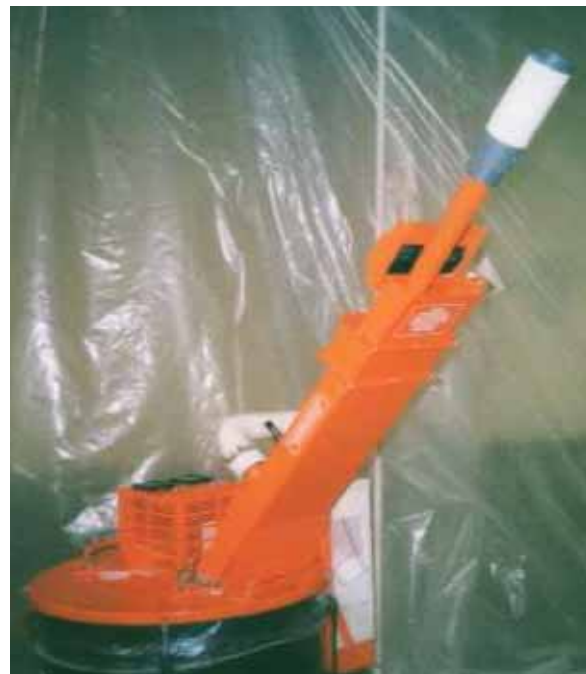
Photograph 2. 6: Manufacturer B Device

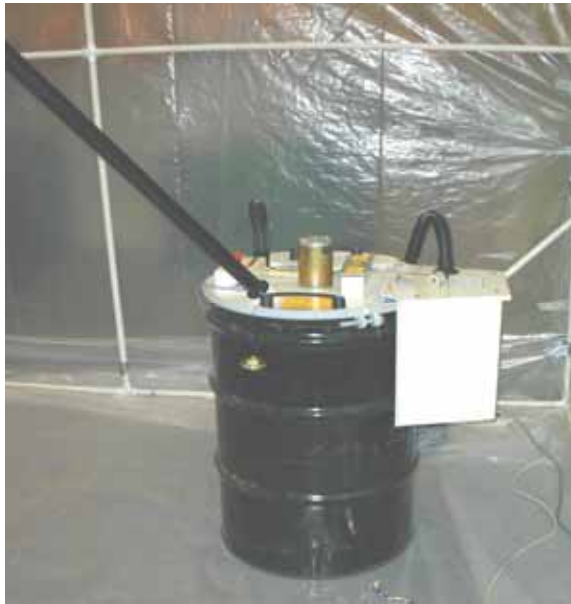
Photograph 2.7: Manufacturer C Device

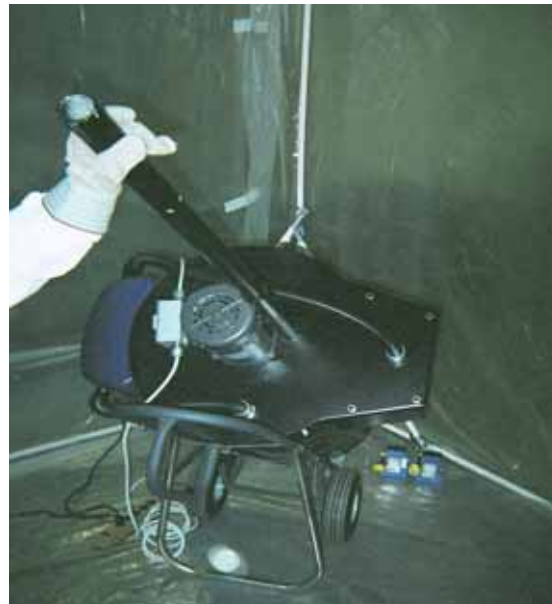
Photograph 2.8: Manufacturer D Device

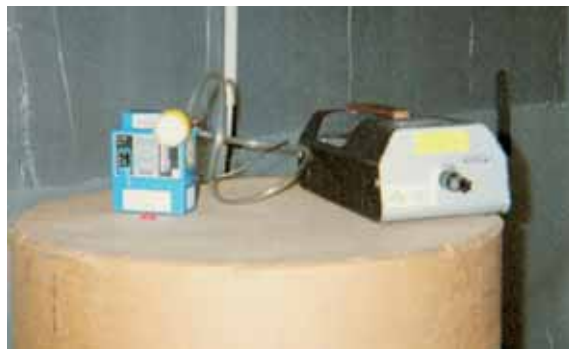
Photograph 3. 1: Air Sampling Pumps and Jerome Mercury Vapor Analyzer

Air samples were collected in the operator's breathing zone during normal operation, filter changes and drum changes, and in selected locations within the containment structure. Jerome measurements were taken both inside and outside the containment structure. Photograph 3. 1 shows the air sampling pump and Jerome analyzer inside the containment structure.

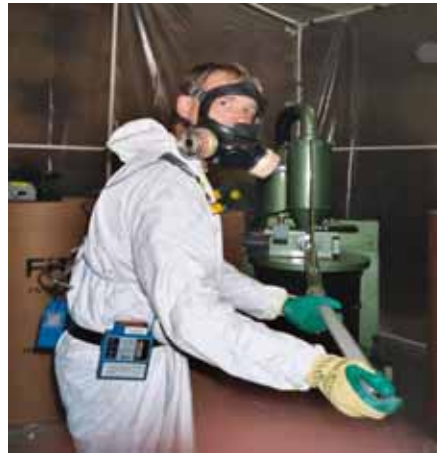
Photograph 3. 3: Feeding Bulbs into the Manufacturer A Device

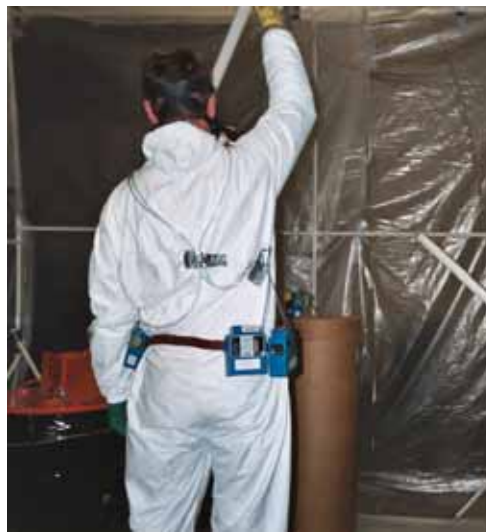
Photograph 3. 4: Feeding Bulbs into the Manufacturer B Device

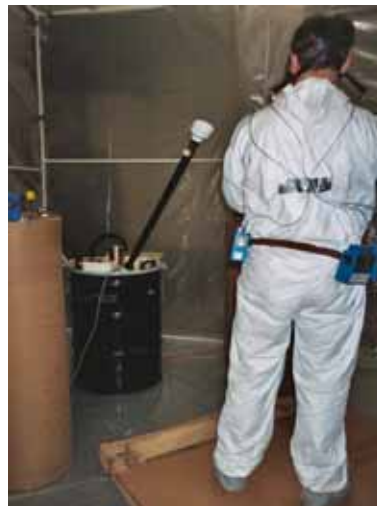
Photograph 3. 5: Feeding Bulbs into the Manufacturer C Device

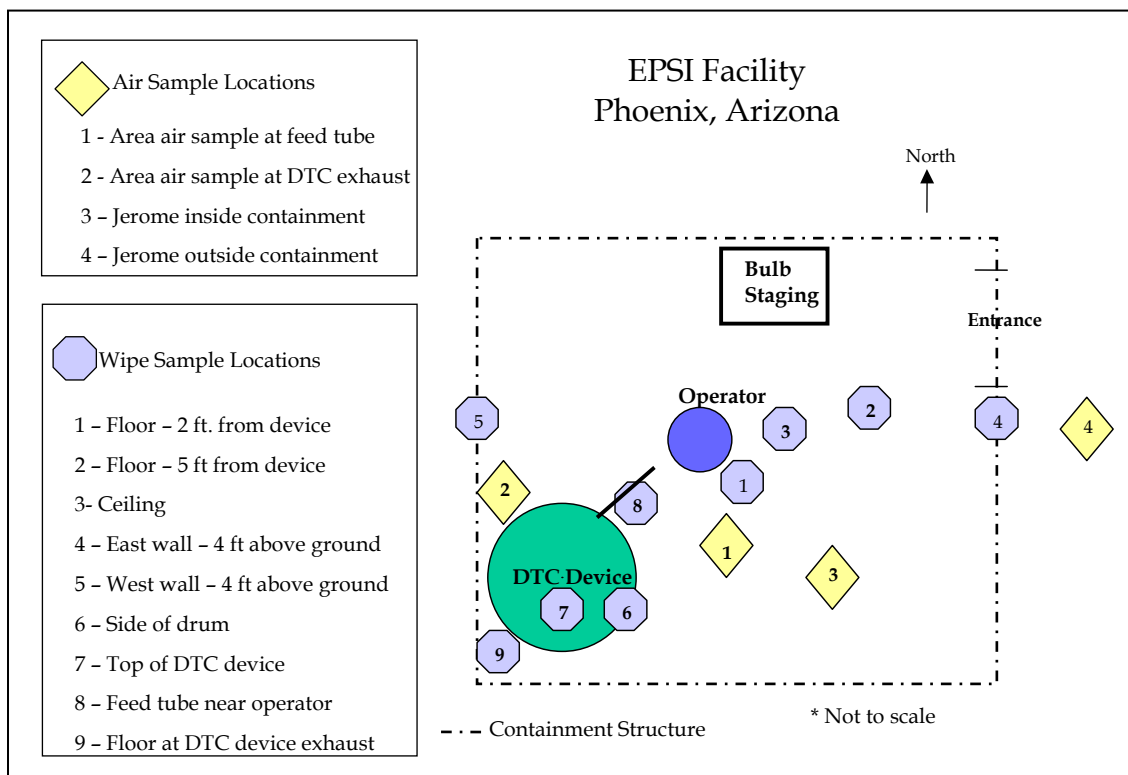
Figure 3. 2: Sampling Locations for Extended Field Test #1

The EFTS was conducted to examine the ongoing performance of each device during extended use and over a range of environmental conditions. EFT #1 was conducted at the EPSI facility in Phoenix, Arizona (EPSI Phoenix), March 24-28, 2003, and it included four DTC devices (Manufacturer A, Manufacturer B, Manufacturer C, and Manufacturer D). Air samples collected during EFT #1 are described in Table 3. 2, and Figure 3. 2 shows the sample collection areas.

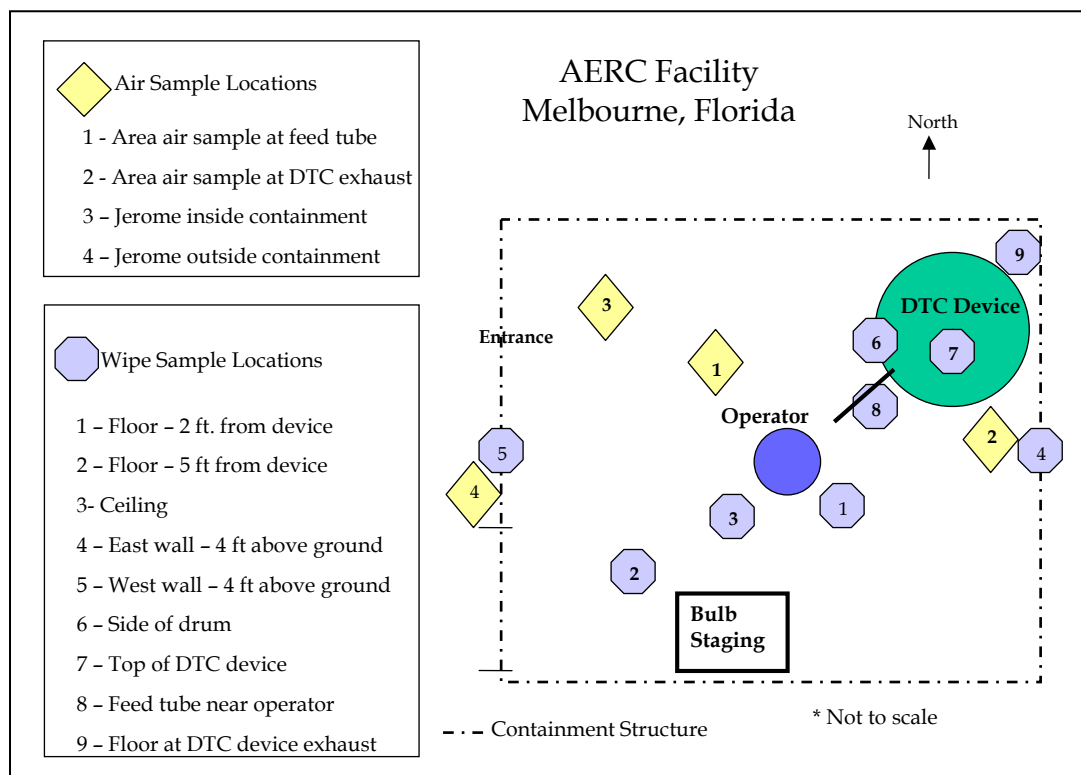
Figure 3. 3: Sampling Locations for Extended Field Test #2

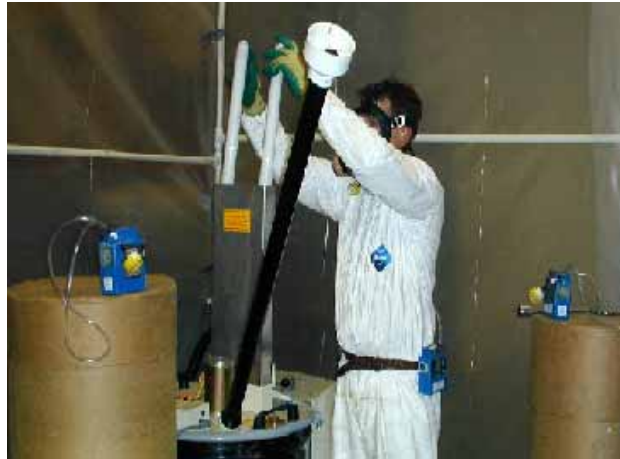
Photograph 3. 6: Crushing of U-Tubes - Manufacturer C Device

The majority of fluorescent lamps processed in the Study were four-foot straight tubes. Although the DTC devices included in the Study were designed to process straight lamps, only two devices (Manufacturer B and Manufacturer C) have attachments that enable them to process “U” shaped fluorescent lamps (U-tubes), as well. At the end of EFT #3 at AERC Ashland, a test was conducted to evaluate airborne mercury levels from the two devices while processing U-tubes. The intent was for both the Manufacturer B and Manufacturer C devices to process enough U-tubes to fill a 55-gallon drum. However, the facility was only able to collect a limited number of U-tubes for the U-tube study. Therefore, the total quantity of U-tubes was divided between the two devices. The Manufacturer B device processed a total of 85 U-tubes, and the Manufacturer C device processed a total of 89 U-tubes.

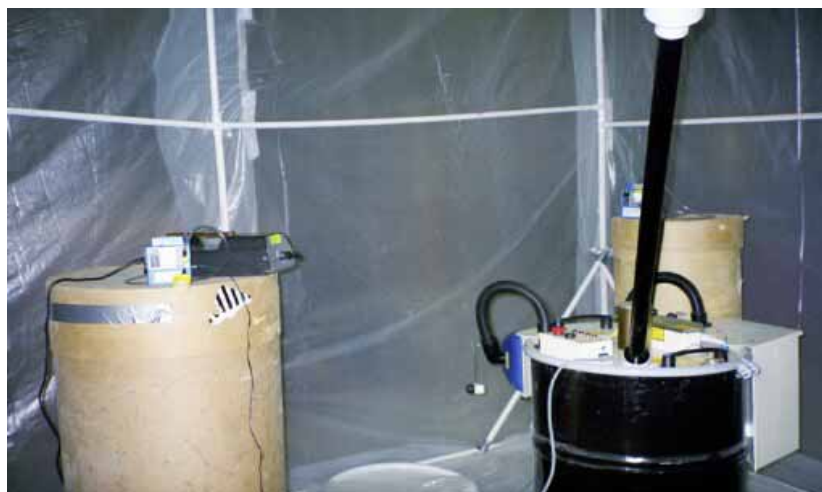
Photograph 3. 7: Placement of Air Sampling Pump & Jerome Analyzer in Relation to DTC Device

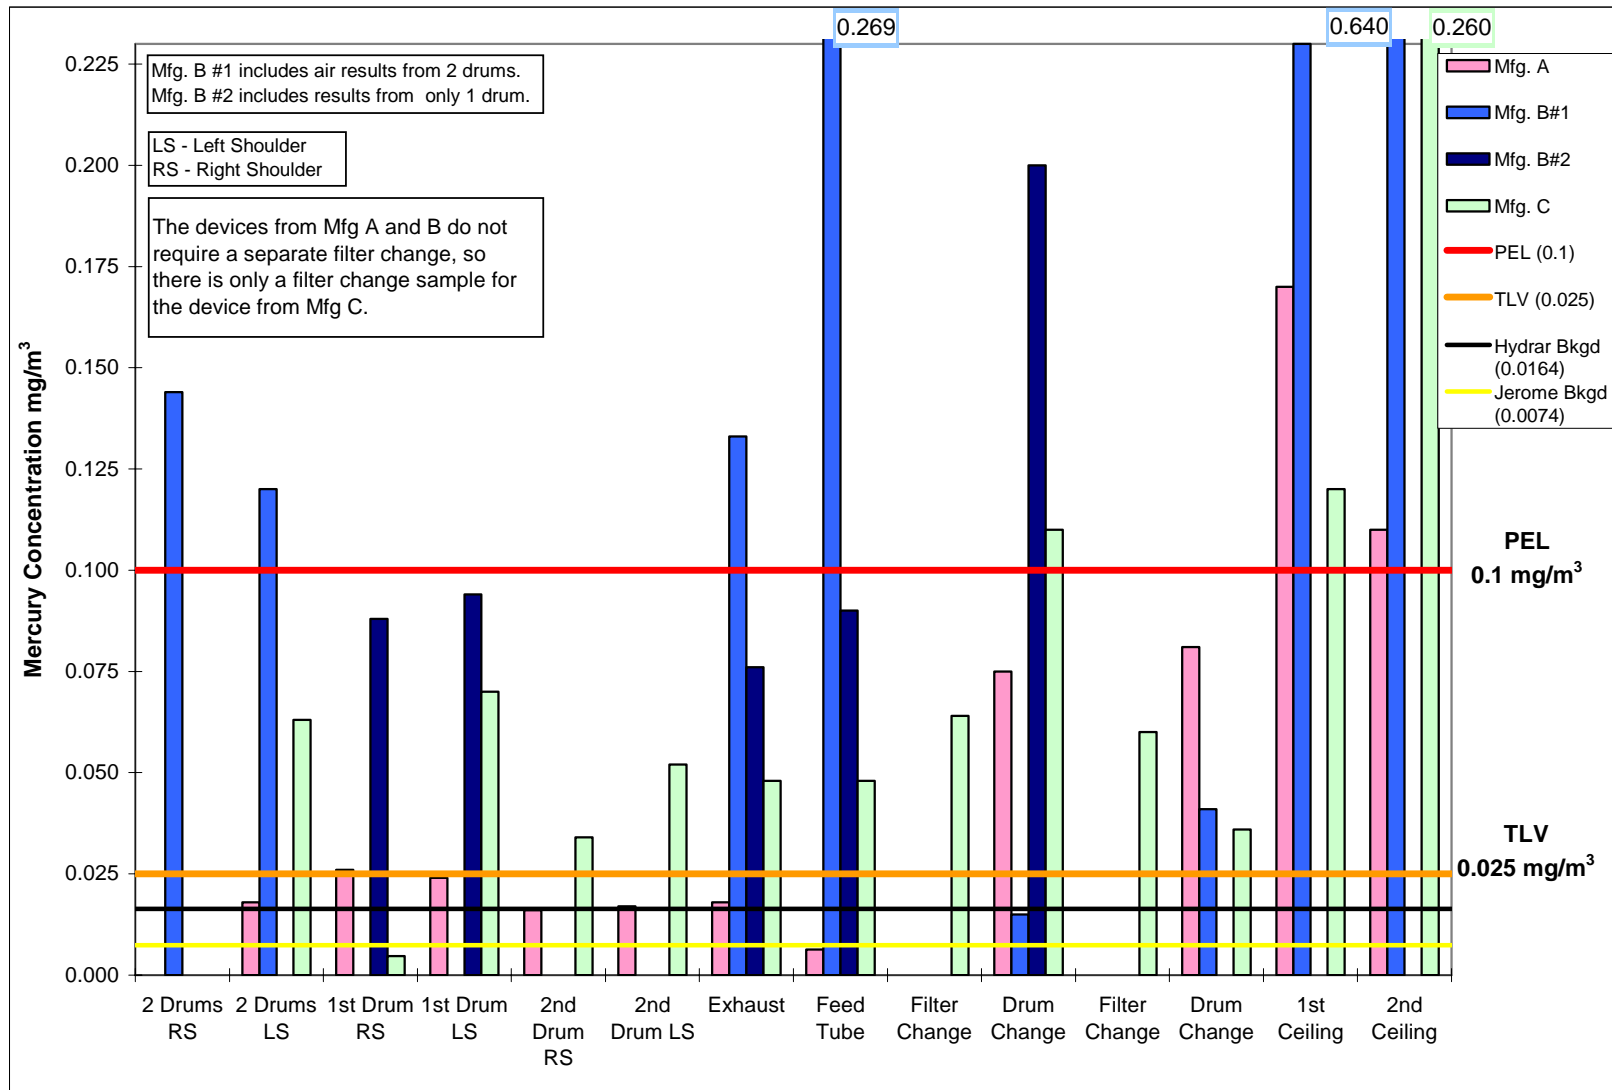
Figure 4.7: Analytic Air Sampling Results, All Devices, Extended Field Test #2^a

^a The TLV is included on the graph as a point of reference. The analytical air samples shown on this graph do not represent eight-hour TWAs (refer to Appendix A, Table 1 for sample durations).

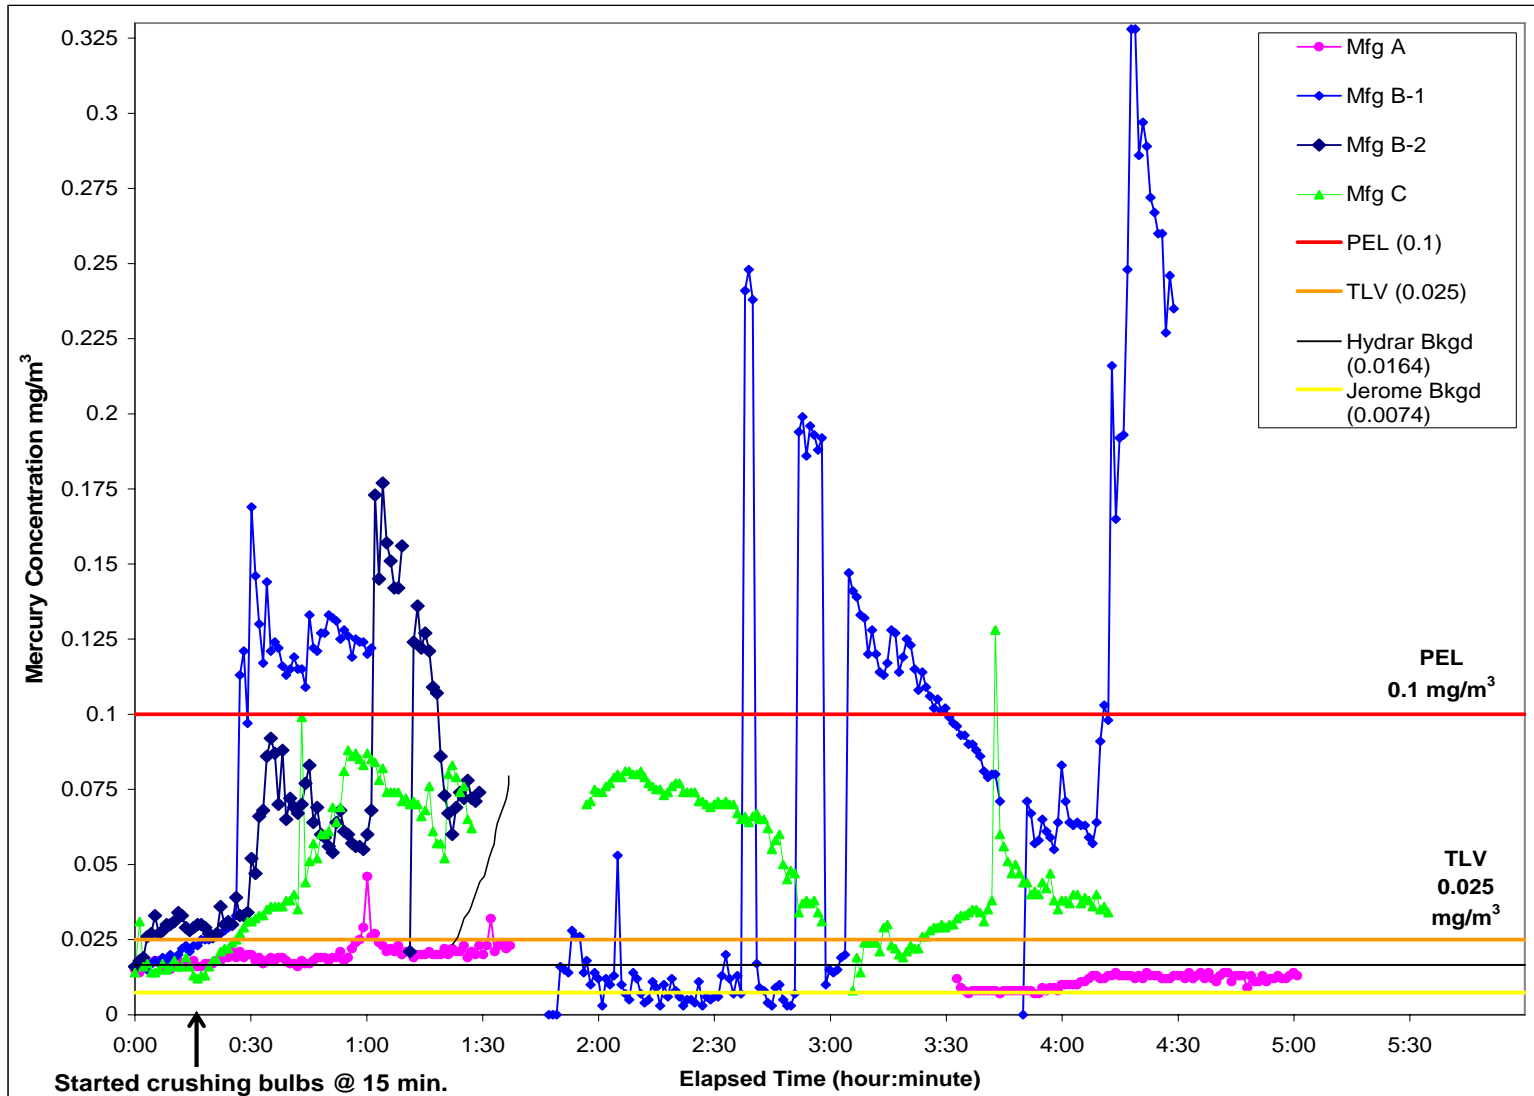
Figure 4. 8: Jerome Results - Inside the Containment, Extended Field Test #2^a

^a The TLV is included on the graph as a point of reference. The mercury concentrations shown on this graph represent instantaneous measurements and do not represent eight-hour TWAs.

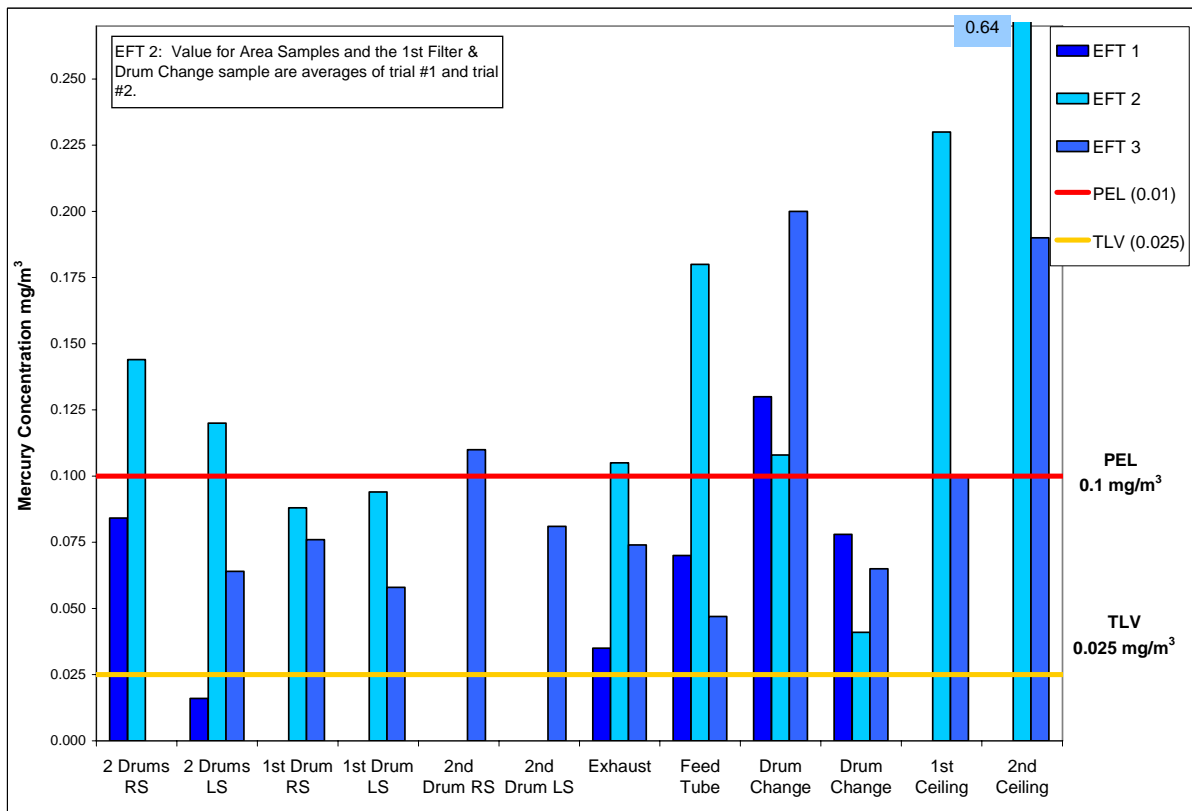
Figure 4. 12: Analytical Air Sampling Results, Extended Field Test Study - Manufacturer B ^a

^a The TLV is included on the graph as a point of reference. The analytical air samples shown on this graph do not represent eight-hour TWAs (refer to Appendix A, Table 1 for sample durations).
